**Technical
Conference
Paper**

High-Resolution Acoustic Imaging for Large Diameter Inspections: Multi-Cavern Case Studies

Zachary Evans, DarkVision, North Vancouver, Canada

**SMRI Fall 2025 Technical Conference
29-30 September 2025
Wichita, Kansas, United States**

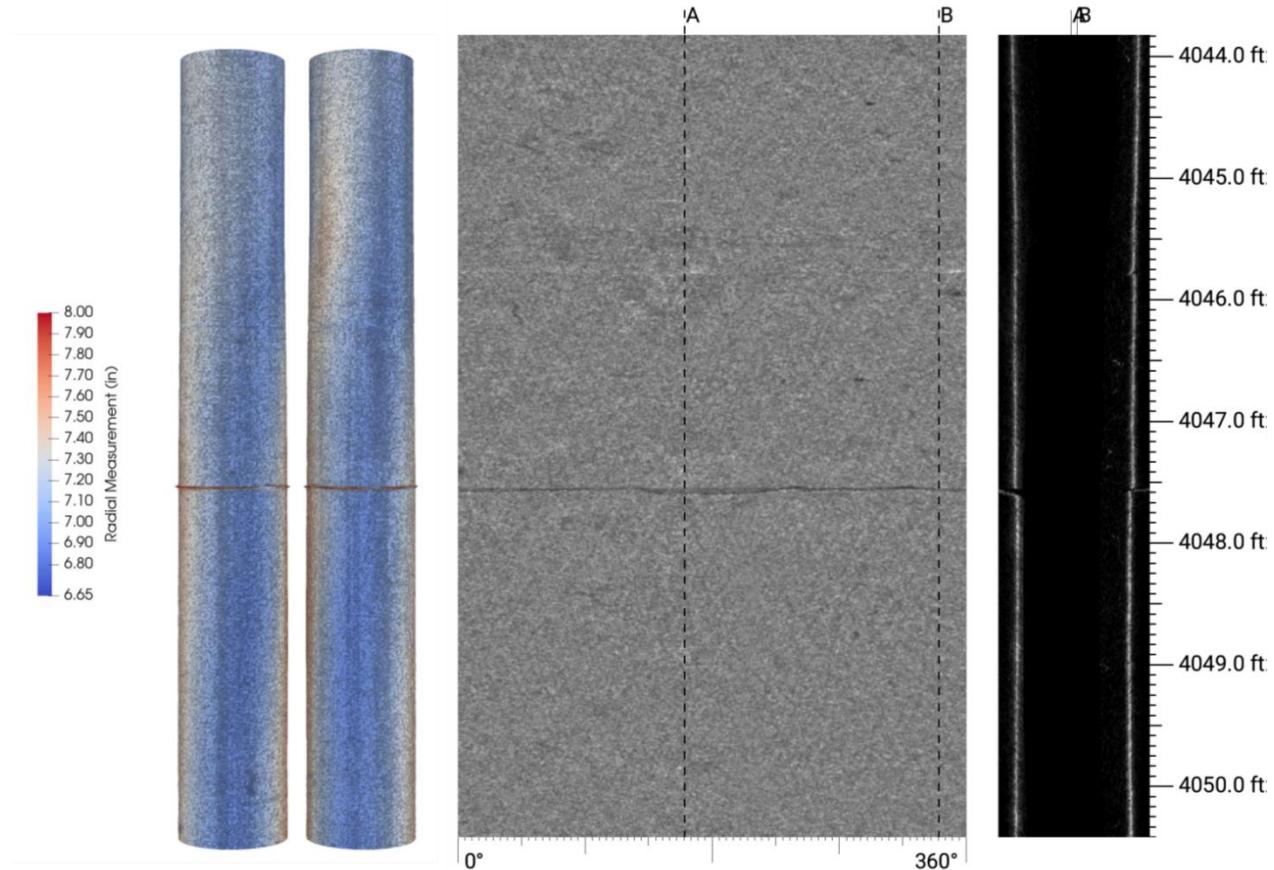
Owing to the radial probe's diffuse imaging, which is unaffected by changes in pipe geometry or component complexity, an evaluation of the connections in this well was also possible. One connection at 4,047.6' was identified as anomalous and exhibited a larger than expected internal diameter, extending consistently and uniformly across the full circumference of the pipe. This internal groove appears to be the result of an imperfect weld in which material has moved away from the interior of the pipe during the joining process (Figure 9 and Figure 10). Figure 11 shows a nominal connection, highlighting the stark difference between the two. While mechanical in nature, this feature will be monitored for future growth.

Figure 9: 3D render (left), Acoustic Intensity Image (middle), and axial section (right) of internal pipe surface showing abnormal connection.

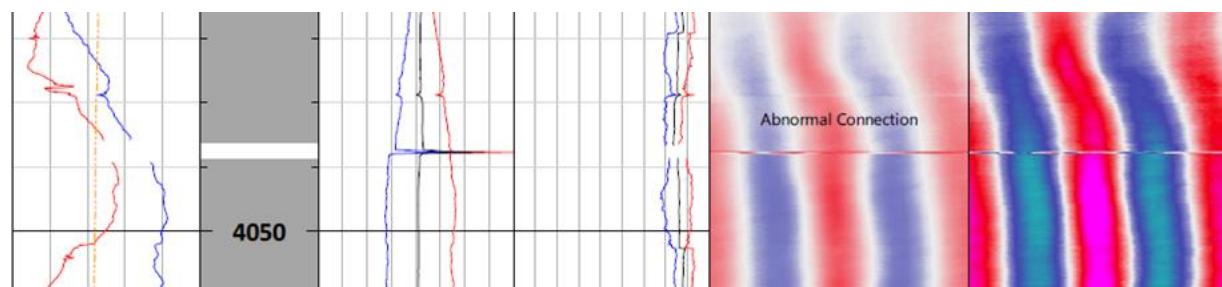
Figure 10: Abnormal connection at 4,047.6'.

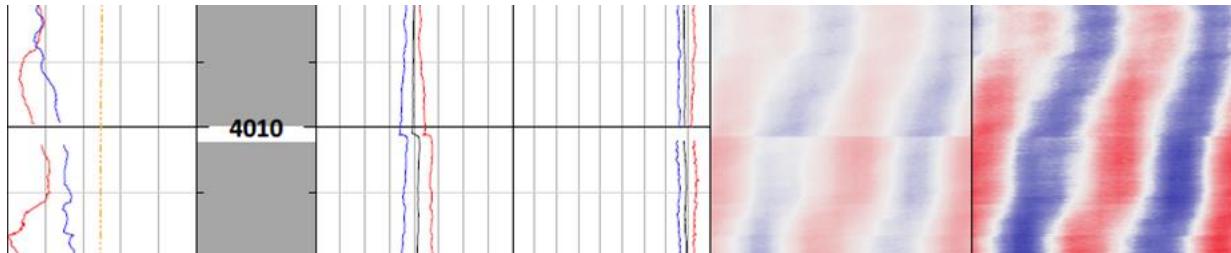
Figure 11: Nominal connection immediately up-hole of abnormal connection at 4,010.2'.

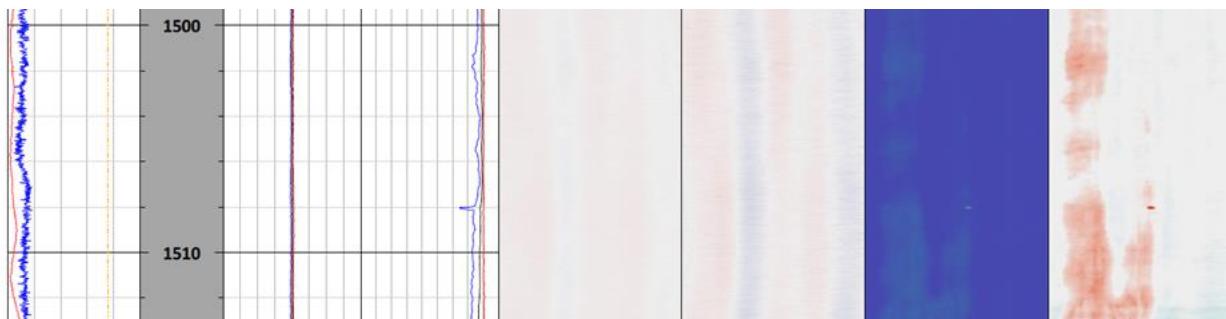
Evaluating the casing string for metal loss features, no significant corrosion or mechanical damage was discovered. Metal loss features ranged from 7-19%, with a maximum penetration of 19% observed at 1,508.1' in an isolated external pit. Given standard pipe manufacturing tolerances of 12.5%, most defects fall at or below a reasonable expectation of initial pipe condition out of the mill. Additionally, with such large pipe, variations in manufacturing patterns are expected, allowing for a practical application of reason when evaluating minimal penetration percentages as seen in this case. High-resolution acoustic measurements were able to accurately identify minor wall loss down to a minimum value of 9% in this thickest section of pipe, with that percentage translating to an identified penetration of just .08" (Figure 12).

Figure 12: Maximum metal loss feature of 19% at 1,508.1'.

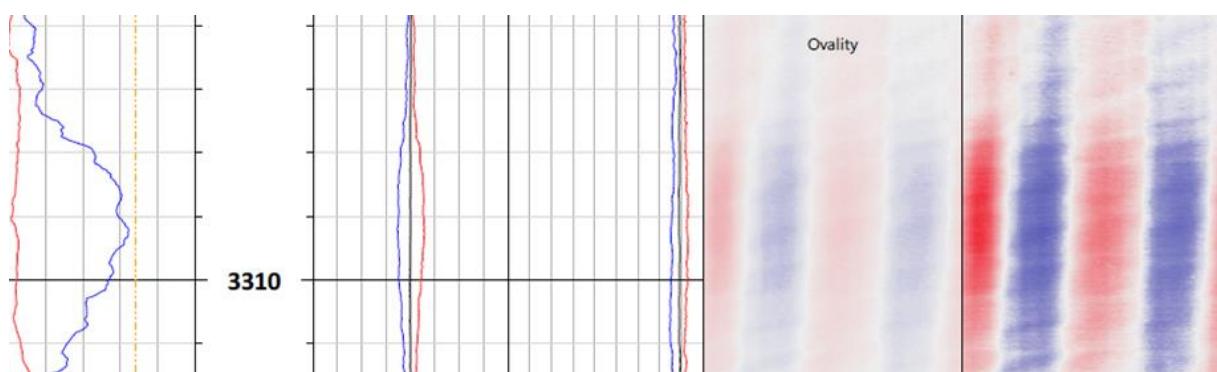
As expected, the casing string did exhibit a considerable amount of ovalization in the regions nearing the top of salt, with a maximum ovality of 8.31% measured at 4,050' (Figure 14). Quantifying ovality in this region is valuable for future regulatory inspections as it should be accounted for if corrosion or other metal loss defects are found within the ovalized zone.

Figure 13: Example of localized ovality measuring 3.23% showing uniform deformation at 3,308'.

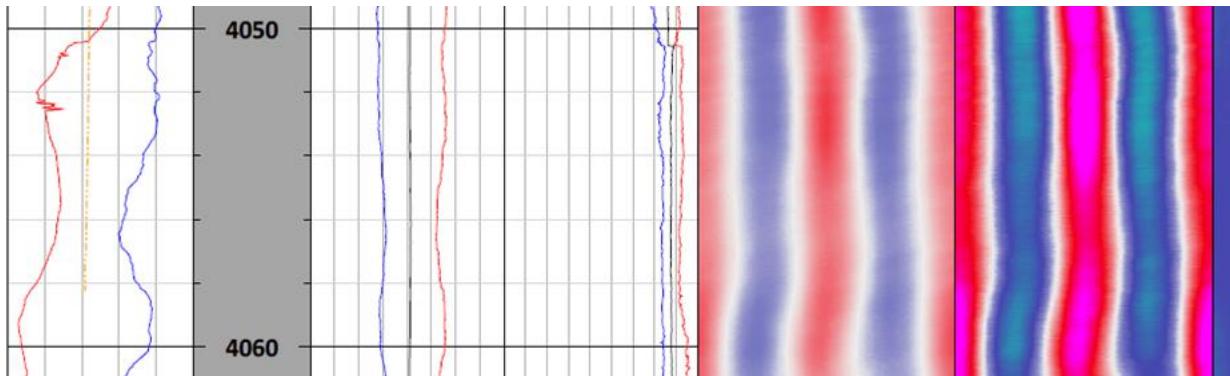
Figure 14: Significant region of general ovalization measuring 8.31% immediately above casing shoe at 4,050'.

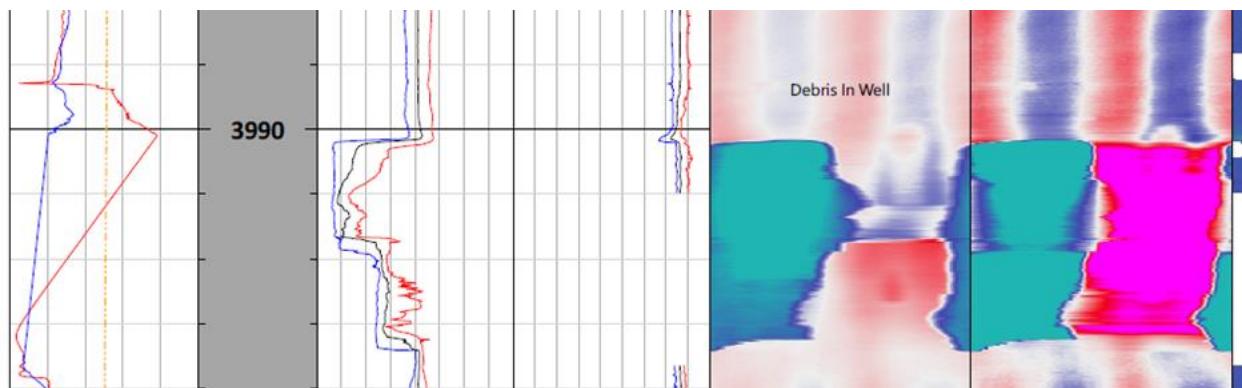
An additional unexpected feature was discovered at 3,990', where a restriction was detected in what appeared to be an area of buildup or debris as indicated by a significant reduction in diameter through this region (Figure 15). The minimum ID measurement of 12.86" was exhibited at the point of maximum buildup compared to a nominal expected inner diameter of 14.3". While this feature was not included in any of the available pre-job well information, discussions with the operator revealed that a temporary packer had been set at this depth and topped off with sand and resin, with this debris then being residual material that remained after drill-out operations.

Figure 15: Log representation of Debris.

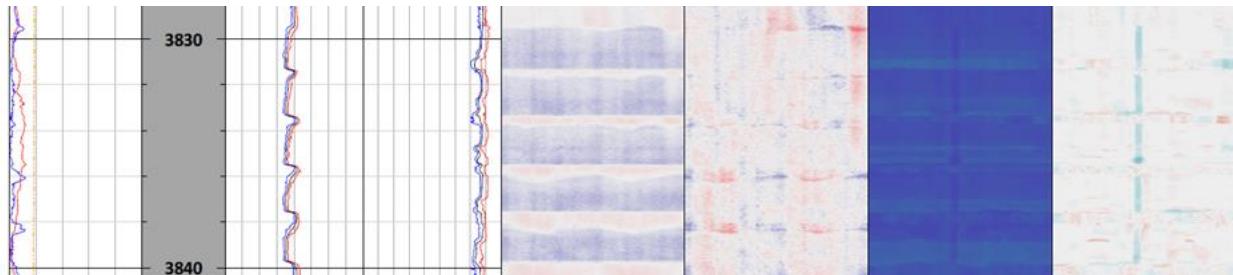
Figure 16: Upper sealing elements of expandable liner at 3,830'.

The visible top of the liner was encountered at 3,829' where the upper elastomer sealing elements of the liner could be observed, as shown in Figure 16. When expanded, these seals create a slight relief in the internal pipe surface, as the surrounding metal material expands further than the metal with the sealing material directly behind it. This creates a very distinct pattern in the radial ID measurements which can easily be used to confirm placement over the zone of interest. This same pattern can be observed at the bottom of the liner at 3,942' where the distinct variations in internal diameter are also detected (Figure 17).

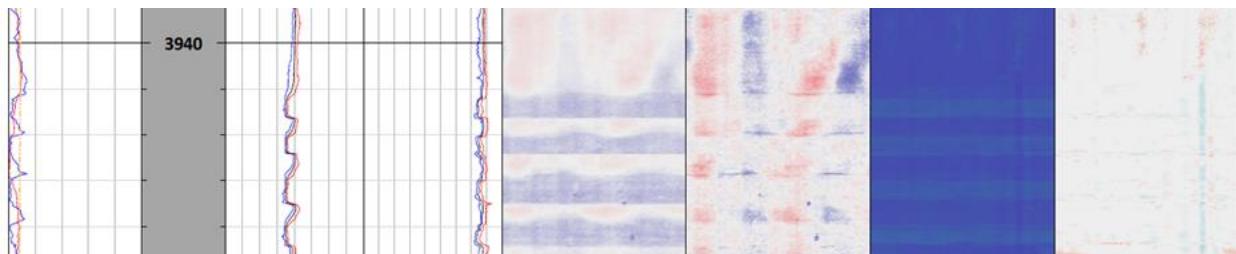
Figure 17: Lower sealing elements of expandable liner at 3,942'.

Based on the manufacturing specification sheet provided by the operator for this specific liner product, after expansion, the liner should display an internal diameter of 13.490" and a wall thickness of 0.371". While some regions of the liner did show ovalization which caused varied ID measurements, non-ovalized segments of the liner were measured as having the exact ID and wall thickness characteristics as expected based on manufacturing guidance.

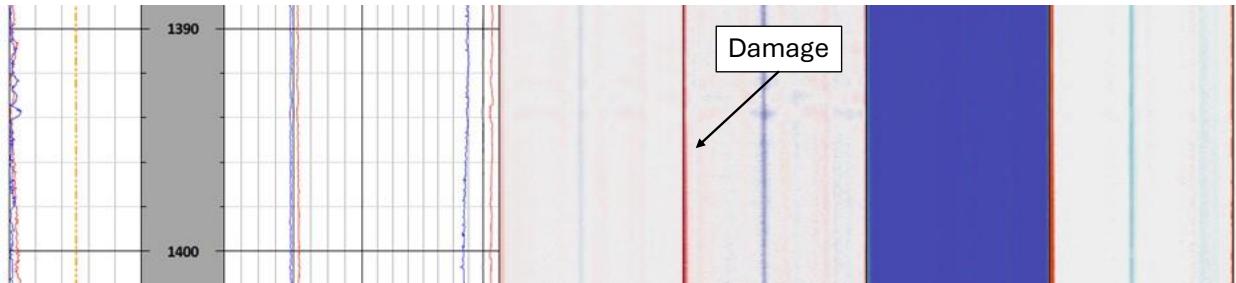
In investigating the presence of corrosion, mechanical damage, or other metal loss features, almost no defects were found throughout the entirety of the well, revealing a casing string with minimal well integrity concerns. In total, only 3 unique joints showed metal loss above the API manufacturing tolerance for new pipe of 12.5%, with a maximum penetration of 19%, or 0.19", at a depth of 1,394.8' in the region of expected corrosion. In these 3 joints, all of which are adjacent and run from 1,295' to 1,415.7', all metal loss features are associated with a uniform vertical defect on the interior of the pipe (Figure 19). While this feature appears to be distinct from the manufacturing weld seam, it could be a function of mechanical damage due to the running of tools or drill wear, as the feature is uniform in its axial orientation and extends across connections without a change in profile. These results confirm the presence of minor metal loss seen near 1,320' identified by previous logs but reveals the true nature of the defect being mechanical in nature and not organic corrosion. The direct measurements confirmed that features previously reported at 2,000' were inaccurate.

Figure 19: Maximum wall loss feature of 19% at 1,394.8' associated with internal damage.

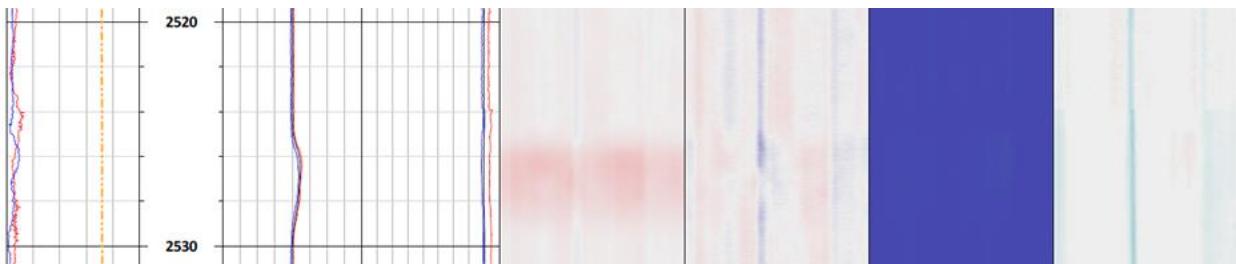
Investigating the suspected damage caused by string shot at 2,530', a generalized region of internal metal loss was observed at 2,526', as shown in Figure 20. Measurements in this region show a larger than expected minimum internal diameter of 17.96", potentially indicating metal loss of 0.02". There is, however, no associated change in wall thickness, indicating that this region of pipe has been displaced but has not seen actual metal loss due to damage or indentation. This finding is of critical importance to the operator in evaluating future well integrity concerns, as even though the minor change in profile will ultimately affect the casing's burst pressure profile, the pipe still retains its full wall thickness.

Figure 20: Region of internal damage likely caused by string shot at 2,526'.

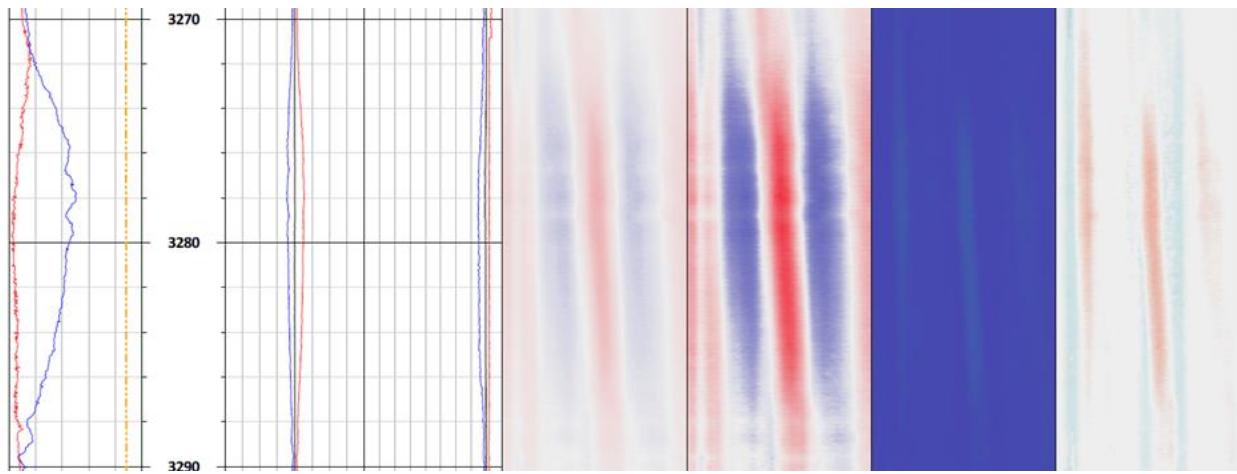
Ovalization was present in the expected regions, beginning at 2,620' and appearing sporadically through the remainder of the well. All instances were below an actionable threshold with a maximum ovality of 2.58% being measured at a depth of 3,278' (Figure 21).

Figure 21: Maximum ovality of 2.58% at 3,278'.

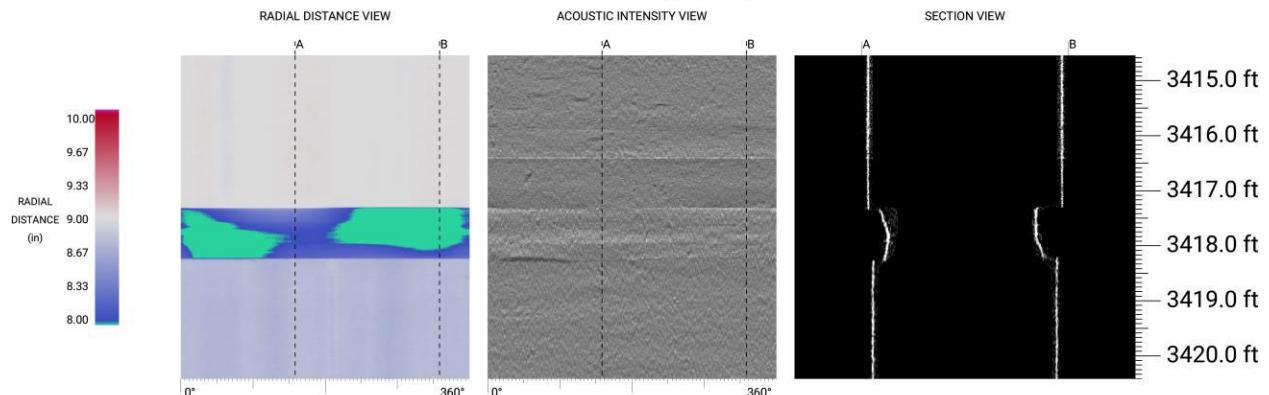
Direct, high-resolution acoustic measurements also revealed two unexpected features. First, a restriction was observed, shown in Figure 22. This feature, roughly 1' in length, presents a region of uniform build up with a minimum diameter of 15.72", restricting wellbore access from the nominal ID of 18" and the joint specific average ID measurement of 17.91". The operator noted that this was potentially the remnants of a previously installed downhole component.

Figure 22: Debris restriction at 3,420' associated with previous plug setting.

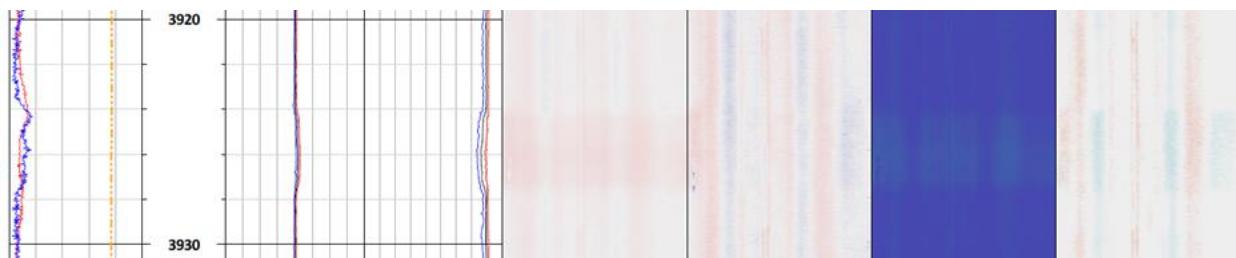
Finally, a minor region of metal loss was observed near the bottom of the scanned interval at 3,924' (Figure 23). Radial measurements in this area are like those observed in the region of suspected string shot

damage. However, there is an associated decrease in wall thickness across this zone. This indentation near the shoe is likely the result of a retrievable plug or similar sealing component. The contrast between this metal loss feature and the metal moved feature highlighted previously at 2,526' shows the value of accurate thickness measurements to truly understand and characterize downhole features in instances where inner diameter caliper measurements may prove insufficient.

Figure 23: Minor casing anomaly at 3,924' potentially associated with previous plug setting.

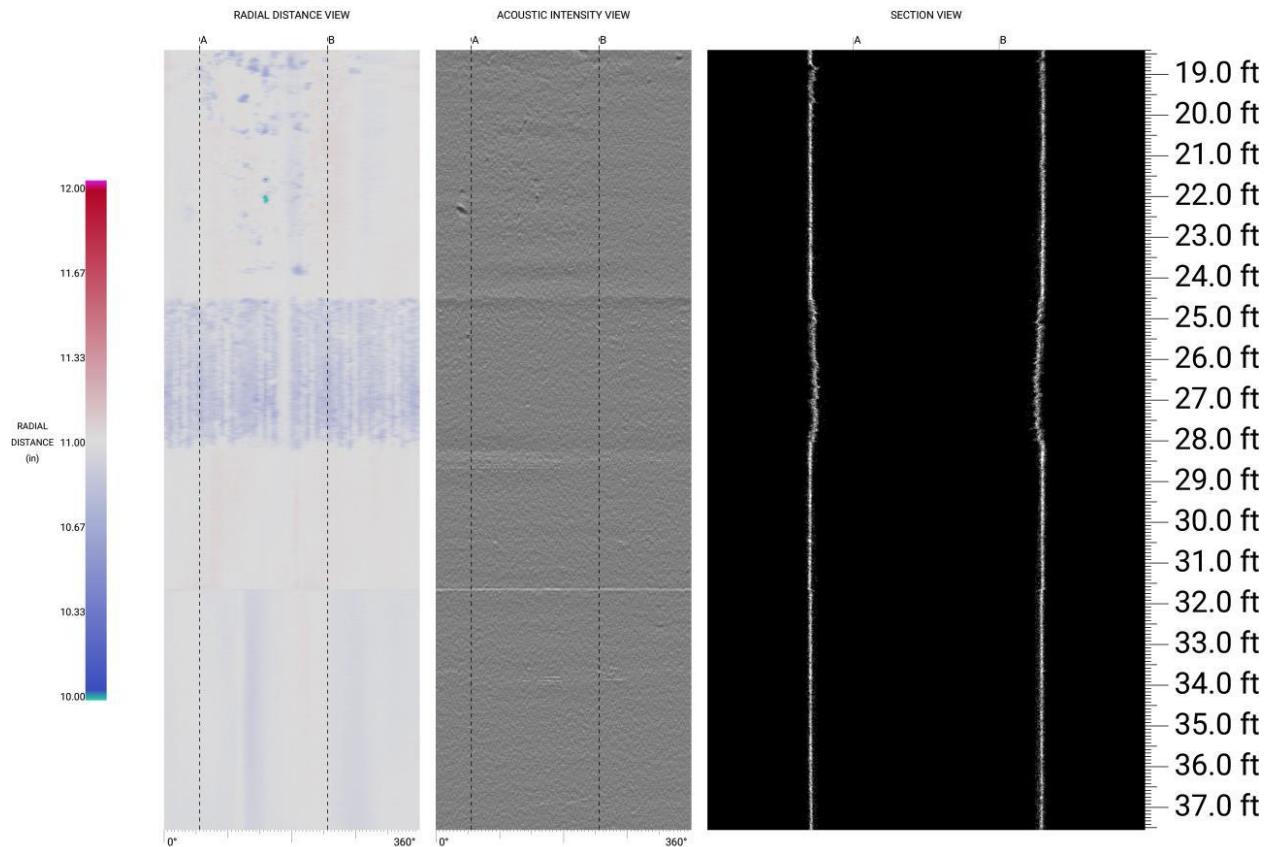
A unique pattern of debris was found at 24', where a roughly 3' circumferential band of internal buildup was observed, shown in Figure 25. However, this region of debris does appear to be friable as radial measurements show clear linear low spots in the debris pattern. These are likely caused by logging tool centralizers passing through the debris while running into the well. In discussion with the operator, other cased-hole logs had shown an unexpected response in this region as well.

Figure 25: Multiple visual representations of buildup observed at 24'.

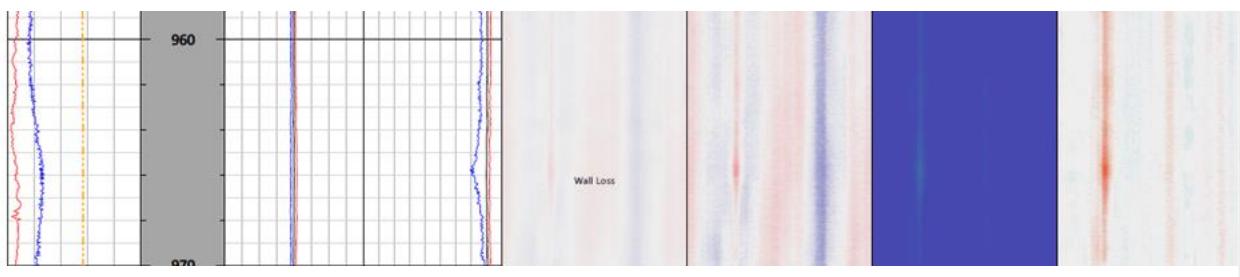
Further investigating the data set for the presence of metal loss, only 2 joints were found with defects above the standard 12.5% API tolerance for new pipe manufacturing, and in both instances the defects measured 0.13" of reduced internal radius compared to nominal, for a percentage deviation of just 13%, and were aligned with the joint's weld seam which is clearly visible in many joints (Figure 26). In total, metal loss features, or imperfections from milling, were found in the range of 3-13%, indicating healthy pipe and establishing a clear baseline with sub-millimetric precision that can be accurately used in future inspections. Even at an inner diameter of 22" and with a pipe wall thickness of 1.0", high-resolution acoustic measurements are capable of reporting single-digit changes in pipe thickness, in this case ranging as low as 0.03" in variation for a percentage penetration of just 3%.

Figure 26: Joint exhibiting 13% metal loss from nominal at 965.8'.

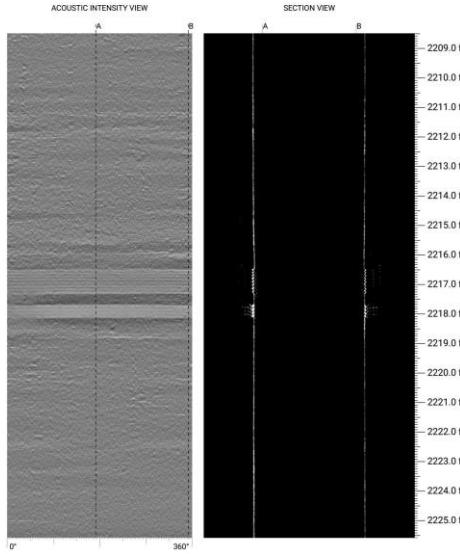
Analysis also revealed an undocumented component in the string, as seen in Figure 29, likely to be a float collar based on acoustic profile and location in the well as discussed with the operator. This highlights the ability of direct measurements to detect all features within a casing string regardless of pre-job documentation, allowing for a complete well schematic and wellbore diagram to be created after inspection for future risk assessment purposes.

Figure 29: Potential float collar detected at 2,216'.

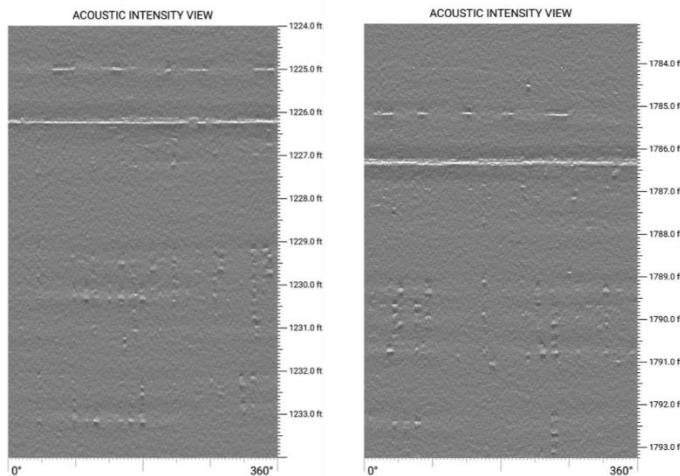
Additionally, a variety of slip marks were found when evaluating the external surface of the pipe (Figure 30). These marks, created immediately above and below the connections while handling and running casing into the wellbore, do not indicate regions of metal loss or indentation, but rather simply external regions of the pipe that have been polished by the placement of casing handling tools. While this was not necessarily a primary diagnostic goal of the logging run, it is notable that this level of precision - identifying minor textural differences on the outer diameter of 24" casing through a 1.0" thick pipe wall - is possible using high-resolution acoustics.

Figure 30: Example of external casing slip marks at 1,226' and 1,786'.
