Technical
Conference
Paper

Replacing Intermediate Casings with Large Diameter Liners to Cost Effectively Reduce Downhole Risk

**SMRI Spring 2025 Technical Conference
27-29 April 2025
Wilhelmshaven, Germany**

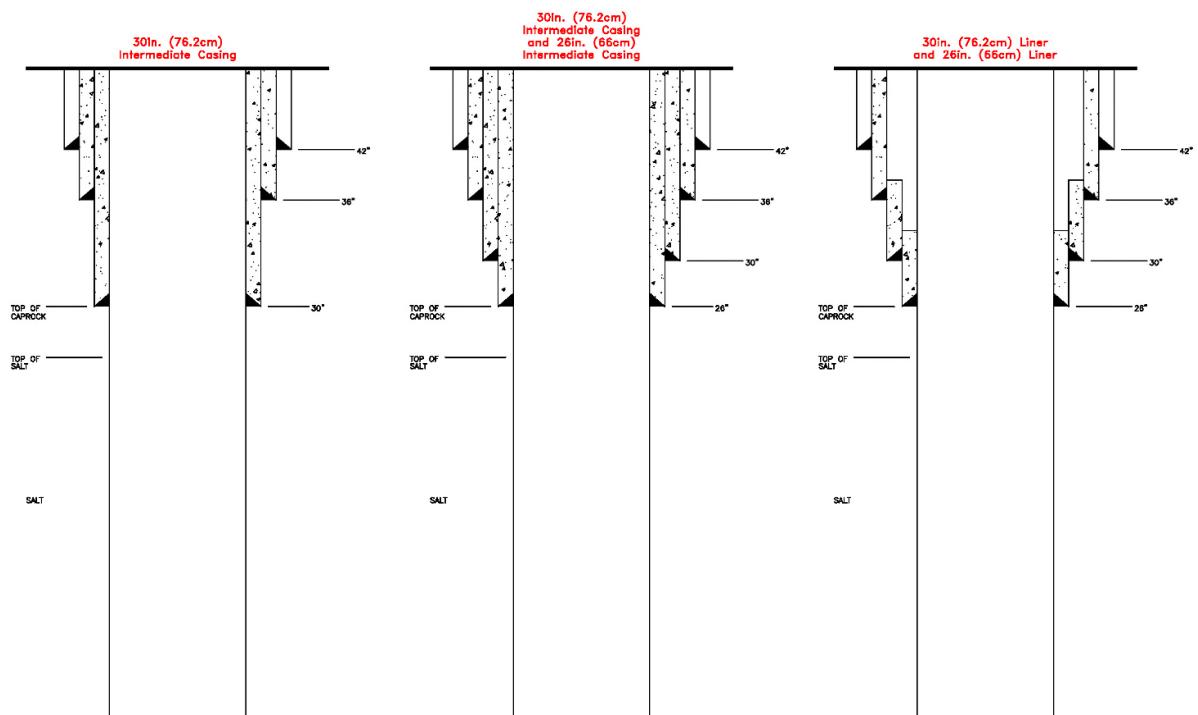
Figure 1 – Intermediate Casing Options

A third casing program option was considered which replaced the 30in (72.6cm) intermediate casing set from caprock to surface with a 30in (72.6cm) intermediate liner and a 26in (66cm) intermediate liner. The 30in 72.6cm) liner would be set at a depth roughly 1,000ft (304.8m) below the 36in (91.4cm) surface casing and would be hung off over 200ft (60.96m) inside the 36in (91.4cm) casing. The 26in (66cm) liner would be set at the top of caprock and hung off 200ft (60.96m) inside the previous 30in (72.6cm) liner. This option reduced the volume of steel in the ground, therefore cost and reduced the length of the open hole sections, therefore the risk.

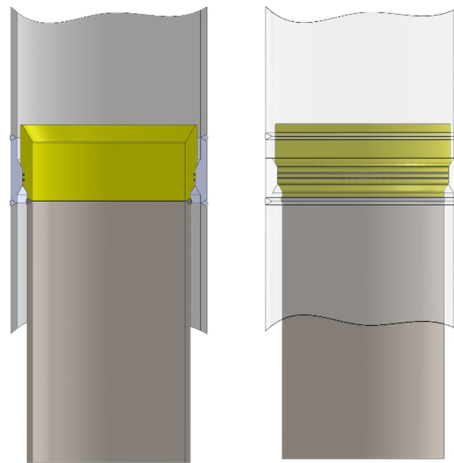
Figure 2 – Liner Landing Ring and Hanger Cross Section

For suspending the liner, an initial design included a custom set of lugs welded into the 36in (91.4cm) host casing that would support the weight of the liner while allowing flow to bypass the hanger during the cementing operation, but relied on bringing cement all the way to the top of the liner to create a “seal” between the two casing sections, which would be difficult to achieve with the large casing and annulus diameters as cement would very likely channel during displacement. A second design was proposed that featured a solid landing ring machined into a sub welded in between casing joints in the 36in (91.4cm) host casing and a mating hanger system that rests on the landing ring inside the 36in (91.4cm) host casing (Figure 2). The hanger features a dual O-ring seal providing a positive seal once the hanger is lowered into the landing ring.

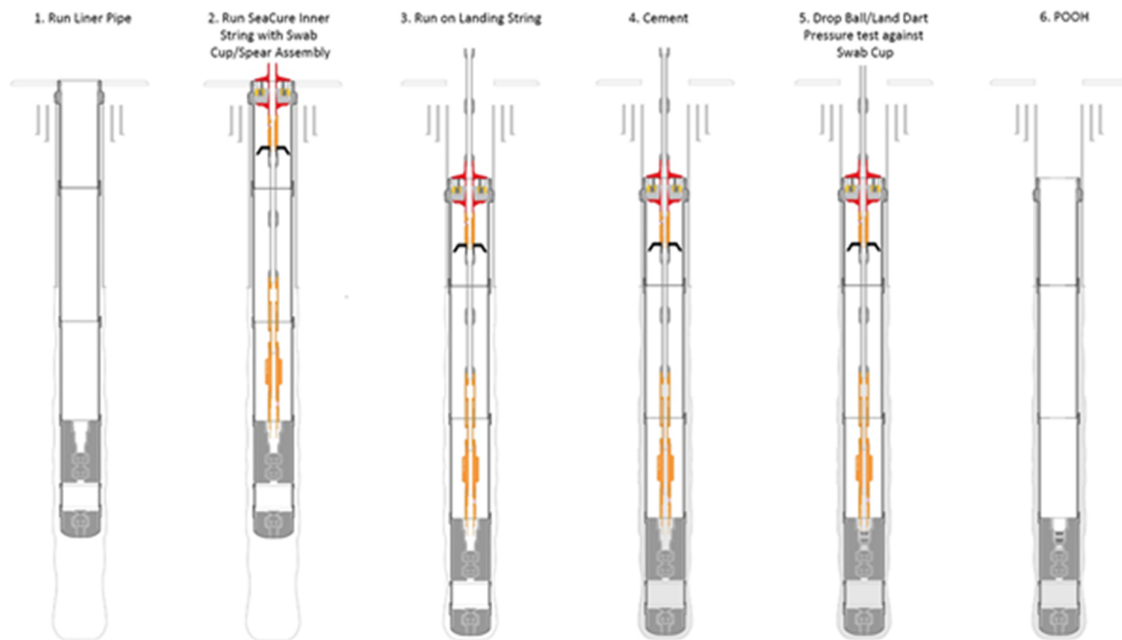
Figure 3 – Liner Running and Cementing Sequence

appropriate cement displacement has been confirmed, creating a proper “seal” at the liner top and a seal at the shoe using cement pumped from the surface. Once the casing is cemented and landed, a small OD brass ball can be dropped from the surface, landing in a ball seat in the bottom of the inner string SeaCure assembly, and the string pressured up to burst a rupture disk, opening up the inner string to the casing ID so that integrity of the casing string can be tested (against the packer and float shoe). The inner string cementing system and liner running process are illustrated in Figure 3.

One of the concerns with cementing a large diameter casing or liner string is cement channeling, allowing excess cement to reach the surface or top of the liner vs. being placed properly downhole. The risk is compounded in this type of liner application where there is a possibility of having issues releasing the liner hanger running tool after the cement job and having cement harden above the liner hanger. To mitigate risk of the liner hanger running tool being cemented in after the job, a rupture disk sub was placed in the landing string just above the liner hanger running tool (spear) with a ball seat just below the disk, allowing a 2.50in (6.35cm) OD contingency ball to be dropped from surface, isolating the upper portion of the landing string to burst the disk, allowing fluid to be circulated above the liner to flush excess cement away from the liner top.

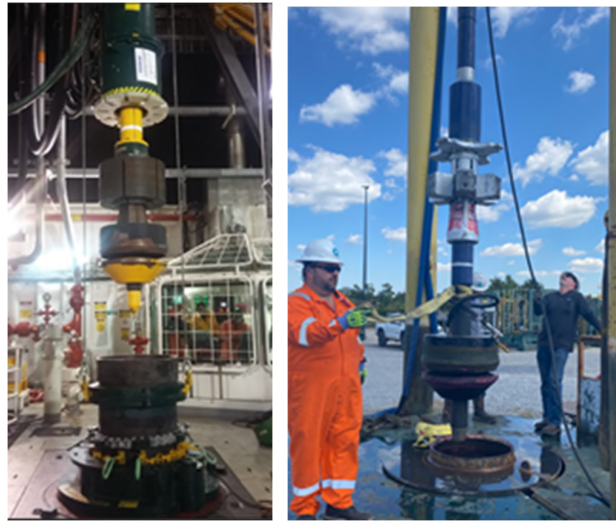
Figure 4 - 30in (76.2cm) CRT Packer Cup Converted to Spear Packer Cup

While landing ring and hanger components were being manufactured, the fishing/running spear was configured to handle the specific weight casing. A packer cup sub designed to adapt a CRT packer cup (Figure 4) to be made up below the casing spear and seal on the ID of the casing, included a contingency rupture disk to allow excess cement to be circulated out of the wellbore in the event that the spear could not be released after the cement job (Figure 5). One concern with the packer cup was sealing on the longitudinal internal weld of the large OD/ID casing string. To eliminate this concern, a layout drawing was made to identify the sealing location of the packer cup inside the top of the liner casing and that area ground smooth to eliminate the weld from protruding in the casing ID, with the weld grind carefully monitored to not reduce the wall thickness of that particular area of the casing that could reduce ratings of the entire liner section. After preparing the ID, the new liner hanger was welded to an 8ft (2.44m) section of casing and a test cap welded onto the bottom to allow a pressure test to be

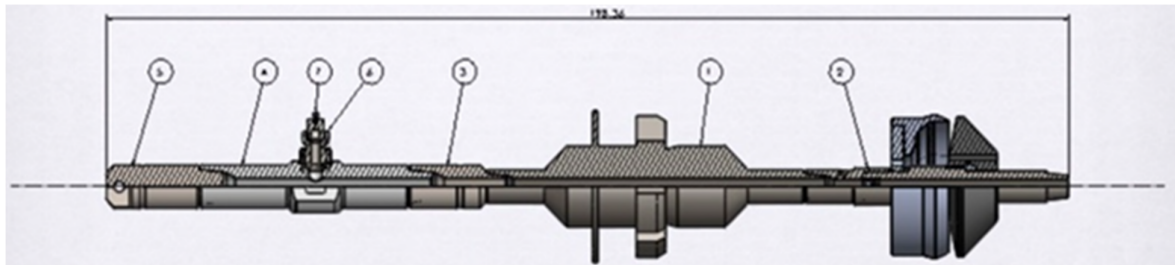
Figure 5 – Spear and Packer Cup Test Assembly

completed once the hanger and packer cup were installed. The entire fixture was housed by a large plate that allowed it to be suspended in a test wellbore, keeping the liner hanger at a safe height for testing, while placing most of the pressure-containing elements safely below ground in the event of a pressure failure.

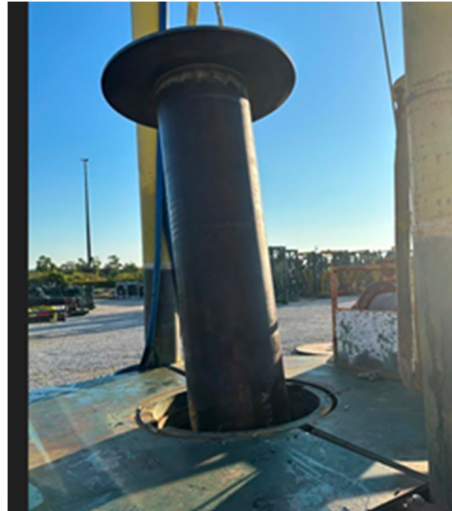
Figure 6 - 30in (76.2cm) Liner Hanger Test Fixture

Once the components were completed, the assembly was moved to the test area for function testing (Figure 6). The test casing with hanger was suspended in the test well and partially filled with water. The packer cup/spear assembly was lowered into the casing hanger and the spear manipulated to bite into the ID of the hanger and casing. Confirmation that the spear was engaged was proven by lifting the spear with a tugger line, picking up the entire test casing assembly. Next, the casing was filled with water, venting air in the system through a port in the upper section of the packer cup with a high-pressure hose and ball valve run above the spear, making it easily accessible at the surface. Once the assembly was full of water, the ball valve was closed and pressure applied to the system, pausing at 250psi (1,723.7kPa) increments and ending at 800psi (5,515.8kPa) (Figure 7). This provided a load on the casing spear equivalent to the weight of the casing and inner string with 500psi (3,447.4kPa) of internal pressure at a 1.5x safety factor.

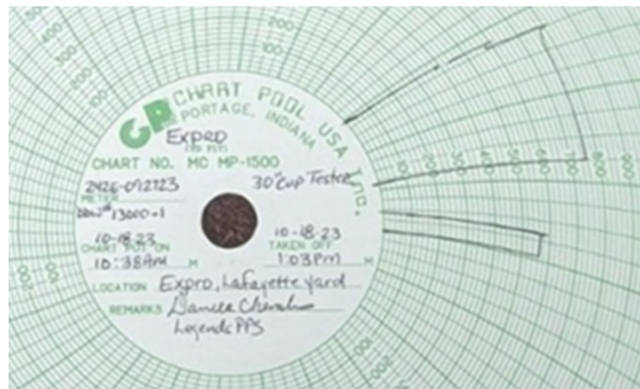
Figure 7 - 800psi (5515.8kPa) pressure test on 30in (76.2cm) Test Casing, Packer Cup and Spear

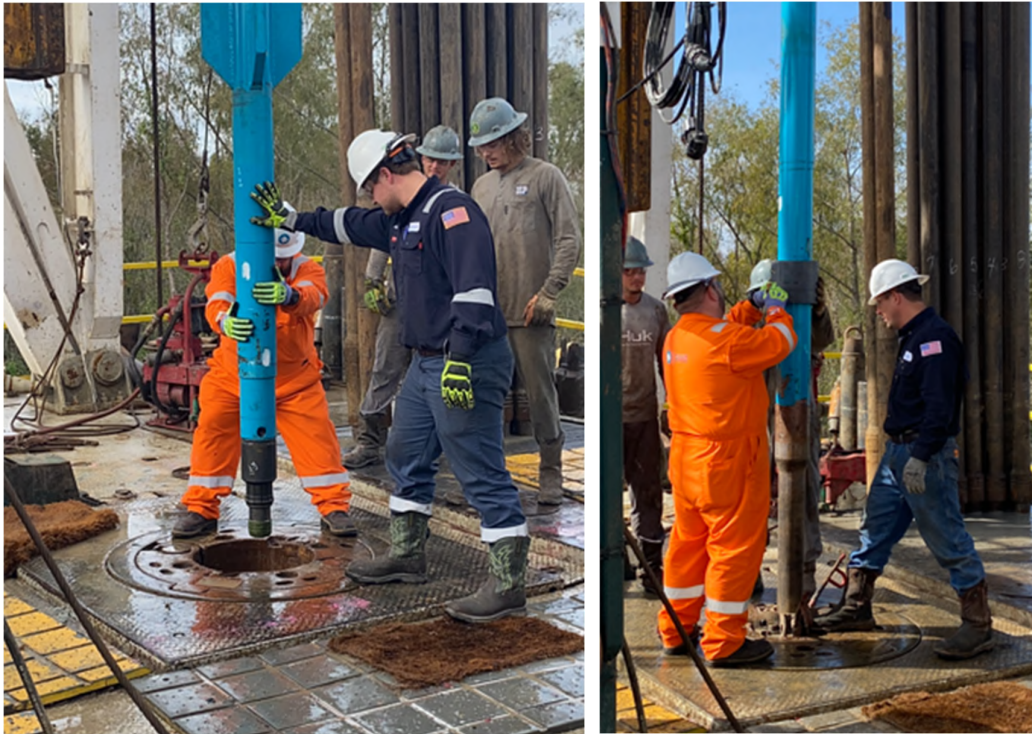
Figure 8 - Deploying Inner-String Latch-In Stinger with Centralizer and SeaCure Slip-Joint Sub

The inner string equipment was rigged up and the stab in adapter, rigid centralizer and slip joints were run in the hole (Figure 8). When the stab in adapter was close to engaging with the float equipment the packer cup and spear assembly were picked up (Figure 9). The O-rings for the hanger were tied to the spear body and the packer cup was given a coat of grease before being lowered into the hanger. Then the spear was engaged into the 30in (76.2cm) liner and was then lowered until the hanger was just above the 36in (91.4cm) casing and the slips were set again. A pressure testing company rigged up high pressure hoses to the valves and hoses connected to the packer cup. 50psi (344.7kPa) of pressure was applied to the packer cup to verify the packer cup had a good seal (Figure 10). The O-rings were installed on the hanger and a thick coat of grease was applied to the O-rings and the outside of the hanger. The 30in (76.2cm) liner was picked up, then the slips, spider and base plate were removed from the top of the 36in (91.4cm) casing. The 30in (76.2cm) liner was carefully lowered into the 36in (91.4cm) casing to ensure that the O-rings were not damaged by the top edge of the 36in (91.4cm) casing.

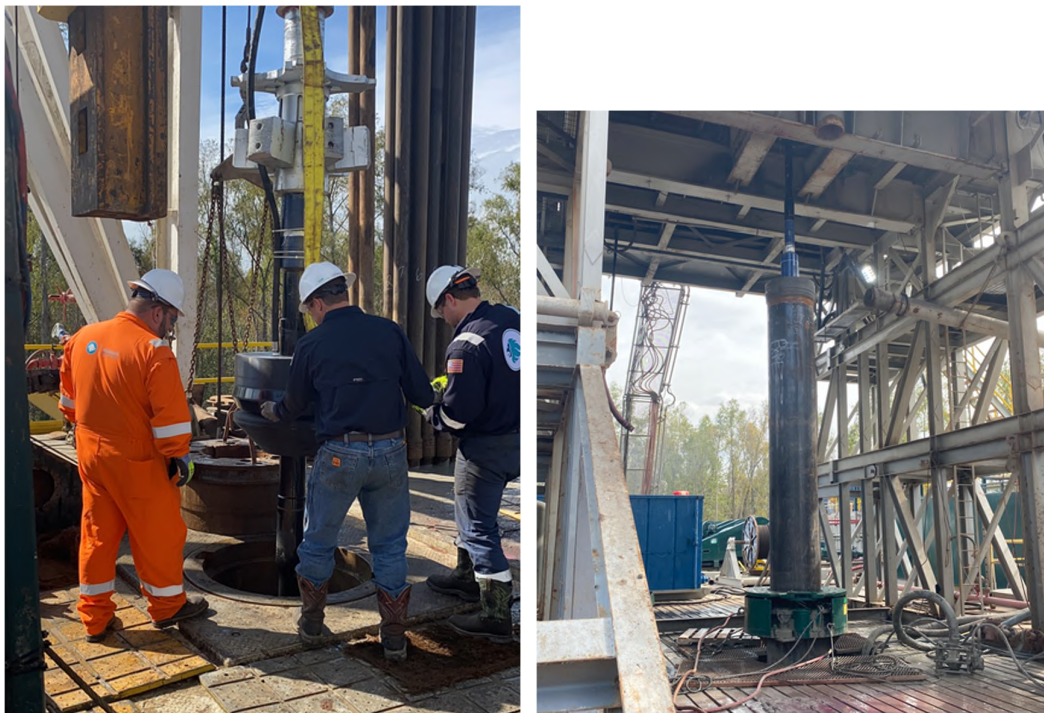
Figure 9 - Deploying Packer Cup and Spear with Liner

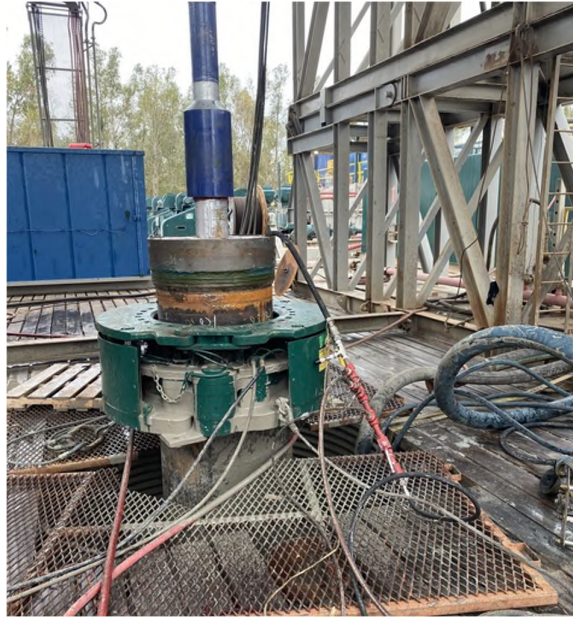
Figure 10 - Pressure Testing Casing Before Running Downhole

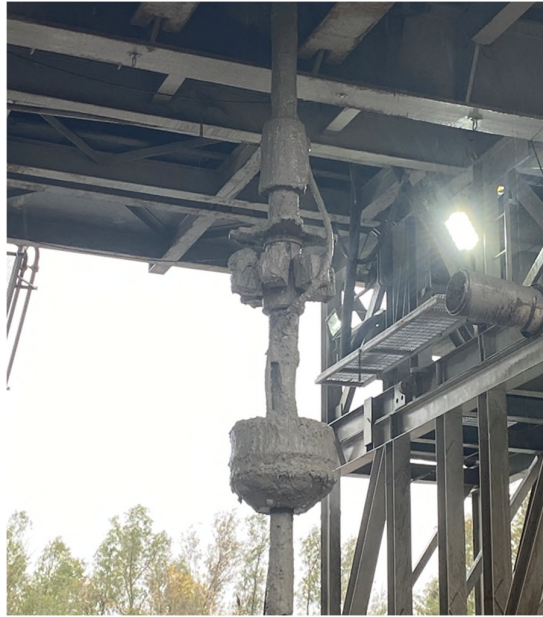
Figure 11 - Cement Laden Spear and Packer Cup After Run

The cementing company was rigged up, lines were tested, then the spacer and cement were pumped. The drill pipe was displaced with mud and the floats were checked. A 1.9in (4.826cm) SeaCure setting ball was placed in the launcher and dropped. Once the ball landed in the circulating sub seat, 2,500psi (17,236.9kPa) of pressure was applied to the ball which burst a rupture disc. This allowed for circulation on the back side of the drill pipe and pressure testing of the casing. However, when circulation commenced, returns were seen in the cellar indicating the packer cup had failed. The decision was made to come out of the hole with the inner string, packer cup and spear assembly. Initial inspection of the packer cup did not show any damage or indications of why a leak occurred. The spear and packer cup were covered in wet cement indicating cement returns through the liner lap (Figure 11).

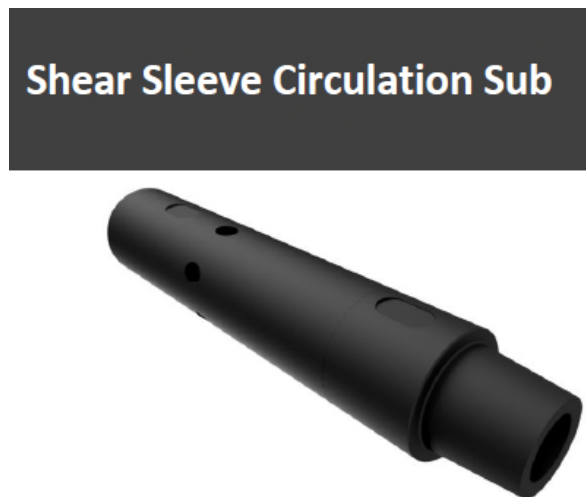
Figure 12 - New Shear Sleeve Circulating Sub

An idea was then proposed to put a circulating sub with down jets in the bottom section of the inner cementing string. Once cementing operations were complete, a circulating sub with jets could be used to circulate out the cement and wash the green cement out of the casing as the inner string was slowly pulled out of the hole. After discussion with the inner string cementing tool provider, a circulating sub was designed, and the plan was to use the sub on the next liner run (Figure 12). The circulating sub was designed to hold pressure during the cement job, then a ball dropped from the surface landed in a shifting ball seat in the sub, exposing a series of flow ports that were designed to provide as much circumferential wall-jetting velocity as the rig's pumps could provide when pulling the inner string out of the hole. The ball seat inside the circulating sub was designed to allow the 1.90in (4.826cm) setting ball to pass during the previous cementing operation, then catch a 2.25in (5.715cm) ball to shift the sleeve down, forcing the fluid out of the now-exposed circulating ports.

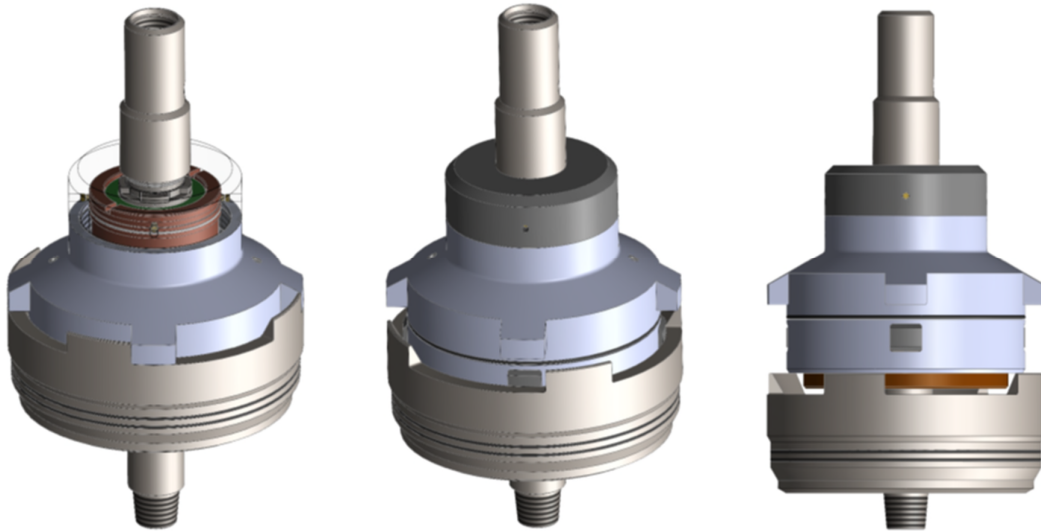
Figure 13 - New Liner Running Tool and Hanger

An examination of previous offshore shelf designs and collaboration between operations, engineering and sales teams led to the design concept of a new liner hanger and running tool design (Figure 13). The new design would replace the packer cup with a proper O-ring seal between the running tool and casing hanger, to maintain alignment and pressure integrity throughout the running and cementing operation. The new running tool features a retractable dog system to support the liner string weight while running in the hole, providing positive tensile and compression loading capability to run the liner to total depth. The dogs are locked in position by a sliding sleeve that is held in position until hydraulic pressure is applied to a mating sleeve to shift the locking sleeve down, removing support for the dogs and allowing them to retract once the liner weight is removed from the system, i.e. landed in the liner hanger landing profile. The new running tool also features torque lugs to transmit right hand rotational torque through the drill pipe and into the liner string to roll the pipe off of any ledges or restrictions encountered in the open hole section of the well. The design of the running tool also provides a mechanical secondary release should the dogs fail to retract properly. One-quarter turn to the left once the running tool is placed into compression moves the dogs into a relief groove, allowing them to be pulled vertically out of the liner hanger. The new running tool also features a contingency ball seat, allowing an additional circulation port to pump channeled cement off of the top of the running tool should both primary and contingency liner releases not function properly.

The design of this new running tool will also allow the liner hanger system to be pre-assembled, picked up and lowered below the rotary to the cellar without any special handling equipment, saving rig time and reducing risk of damage to personnel or equipment.

At the time of this report, the new 30in (76.2cm) running tool internal components have been successfully tested by pumping a 2.00in (5.08cm) OD dart through the new running tool, then dropping a 2.25in (5.715cm) OD ball into the hanger ball seat to shear the screws and shift the dog sleeve down, exposing the dogs and allowing them to retract successfully. The remaining components have been received, and full-scale testing will occur mid-April 2025.
