**Technical
Conference
Paper**

High-Resolution Acoustic Imaging for Large Diameter Inspections: Multi-Cavern Case Studies

Zachary Evans, DarkVision, North Vancouver, Canada

**SMRI Fall 2025 Technical Conference
29-30 September 2025
Wichita, Kansas, United States**

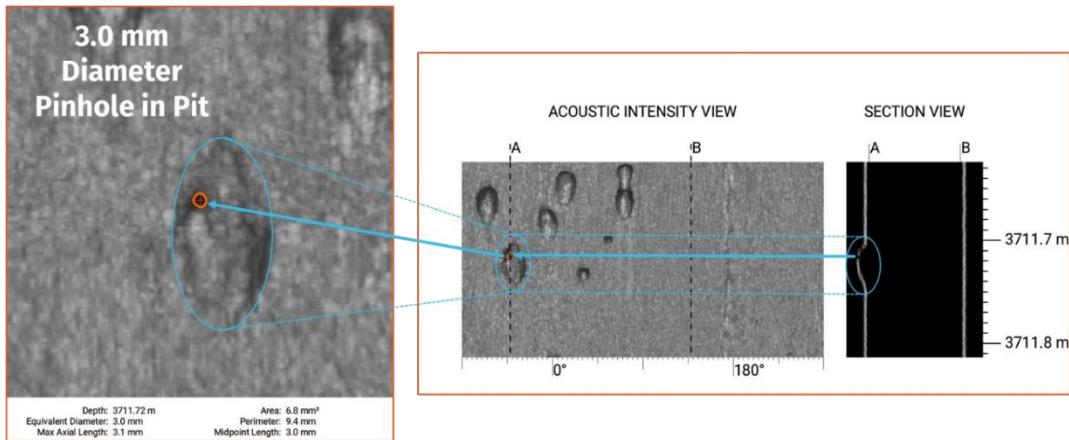
This approach creates significant advantages in detecting and measuring small holes, complex corrosion, pinholes, breaches, or other interacting defects. Figure 3 shows an unwrapped acoustic intensity view or acoustic amplitude visualization showing a 3.0 mm through-casing pinhole found inside of a region with broader general corrosion. The complexity of this defect would make it challenging for legacy integrity assessment tools to detect, size, or depict the true nature of the breach.

Figure 3: 3.0 mm Pinhole in Pit assessed from a downhole log using diffuse reflections from the acoustic imaging technology.

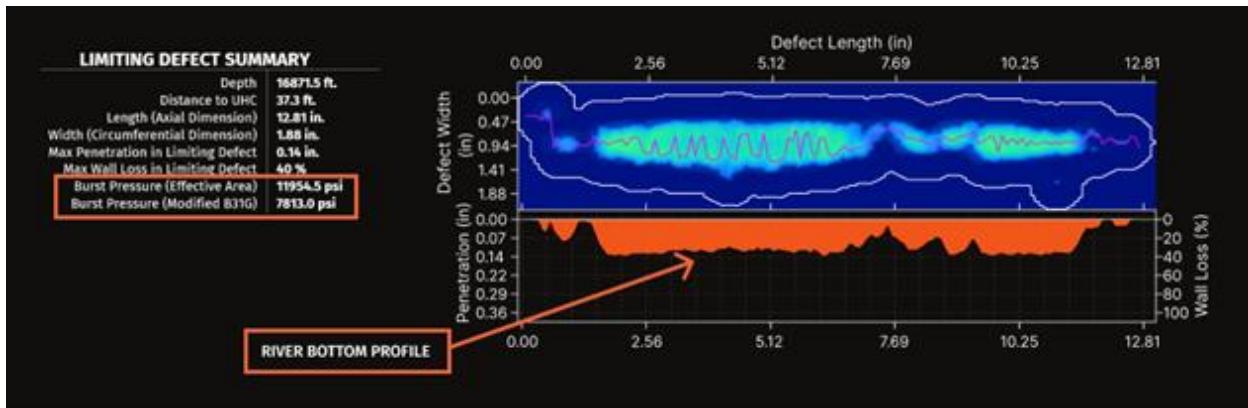
Figure 6 shows an example of the advanced burst pressure analysis prepared using this technology to assess a defect. A zoomed-in image of the limiting defect and its river bottom profile is shown in the plot on the right as a blue shape and the calculated burst pressure values on the left in the Limiting Defect Summary. The ability to accurately size this defect's axial length, utilized by the Effective Area calculation, gives a maximum burst pressure much higher than that determined by Barlow – where only the maximum defect depth is considered.

Figure 6: Limiting defect burst pressure assessment of the limiting defect in a casing joint with 40% wall loss.

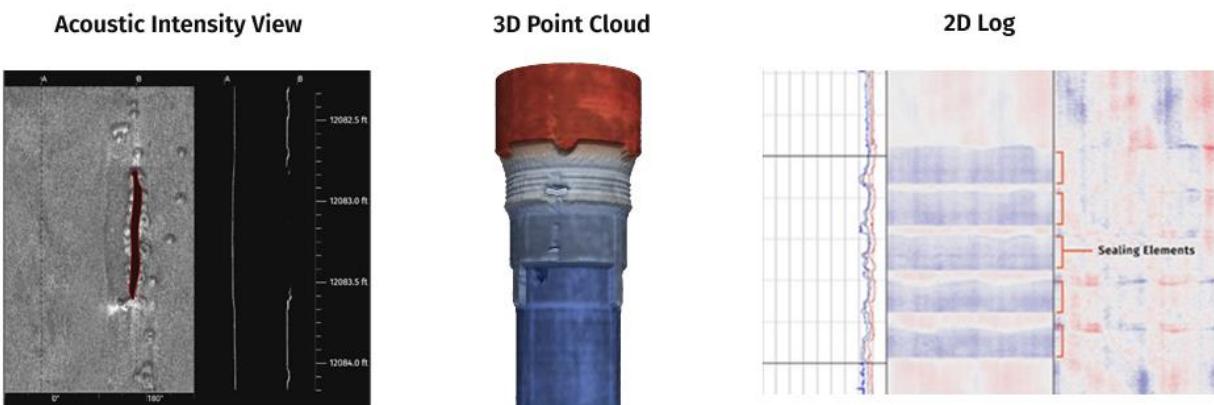
Figure 7 shows three examples that illustrate the versatility of high-resolution acoustic imaging. From left to right, the first shows an acoustic intensity map featuring a small axial split – a feature that would have been missed by other tools. This intensity map is exclusive to the diffuse imaging response and is valuable for visualizing breaches and other unique and subtle surface texture features that create a visible response compared to the surrounding healthy casing. The second example shows how 3D point clouds of data are used to generate a precise 3D rendering of a damaged liner hanger. Lastly, a 2D log shows the thickness measurements of a gas storage well that indicates the successful placement of an expanded liner.

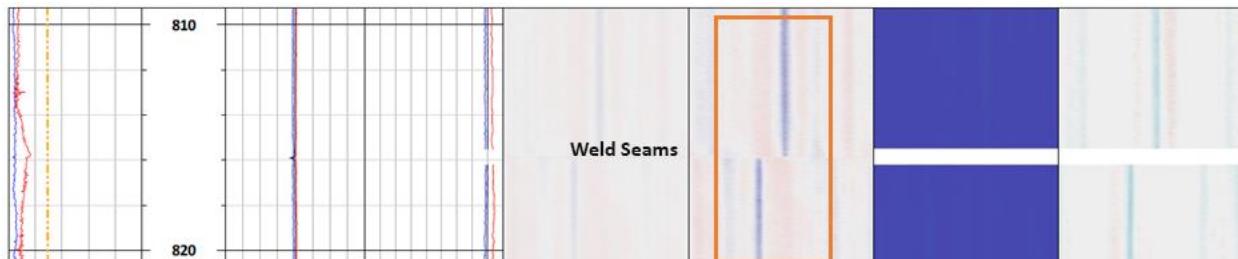
In analyzing the results of this run, a review of the data confirmed the expected internal diameter and wall thickness of the up-hole pipe section, which extended from surface to 3,417', as 18" and 1.0" respectively. Results also showed expected welded connections, all of which appeared intact and without damage or deformation. In some joints, the presence of the manufacturing weld seam could be observed along with very minor manufacturing patterns typical of new, modern tubulars (Figure 18).

Figure 18: Example of visible weld seams in two adjacent joints at 816'.

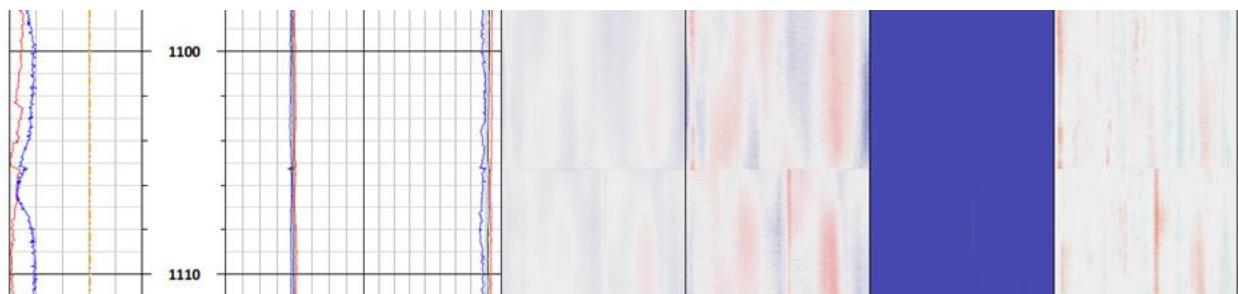
Evaluation of the welded connections in the casing string yielded no areas of concern, as all connections were observed to be intact and without damage. Observation of the connections also confirms the presence of the weld seam in most joints (Figure 27).

Figure 27: Example of a healthy connection at 1,105' also showing a weld seam observable in the lower joint but not upper pipe.

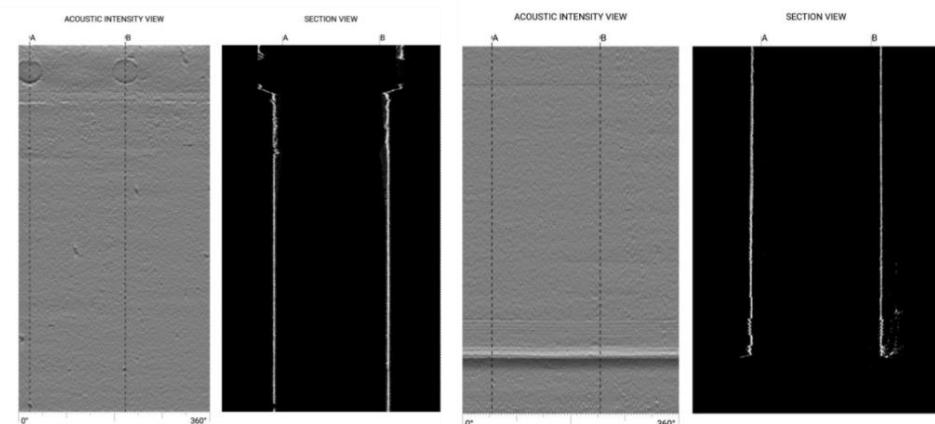
Figure 28: Left, Acoustic intensity and axial section of lower ports and, right, acoustic intensity and axial section view of cavern neck.

In this case study, the fluid top reached the top of the casing into the hanger and lower elements of the assembly, providing a clear image of the lowermost ports (Figure 28). This capability allows for maximum coverage of near surface casing condition up to and including the hanger, which avoids the limitations of legacy technologies unable to detect or quantify near surface corrosion due to physical limitations associated with the wellhead. Similarly, the ability to drop the radial probe of the tool string through the casing shoe and into the cavern neck allows for the same kind of fully comprehensive evaluation of the string, examining not only the condition of the shoe but also the cavern neck, measuring and imaging any potential washouts.
