EFFECT UPON ENVIRONMENT OF BRINE CAVITY SUBSIDENCE AT GROSSE ILE, MICHIGAN — 1971

By: Kenneth K. Landes, Thomas B. Piper

April 1972

Sponsored by: Solution Mining Research Institute and BASF Wyandotte Corporation

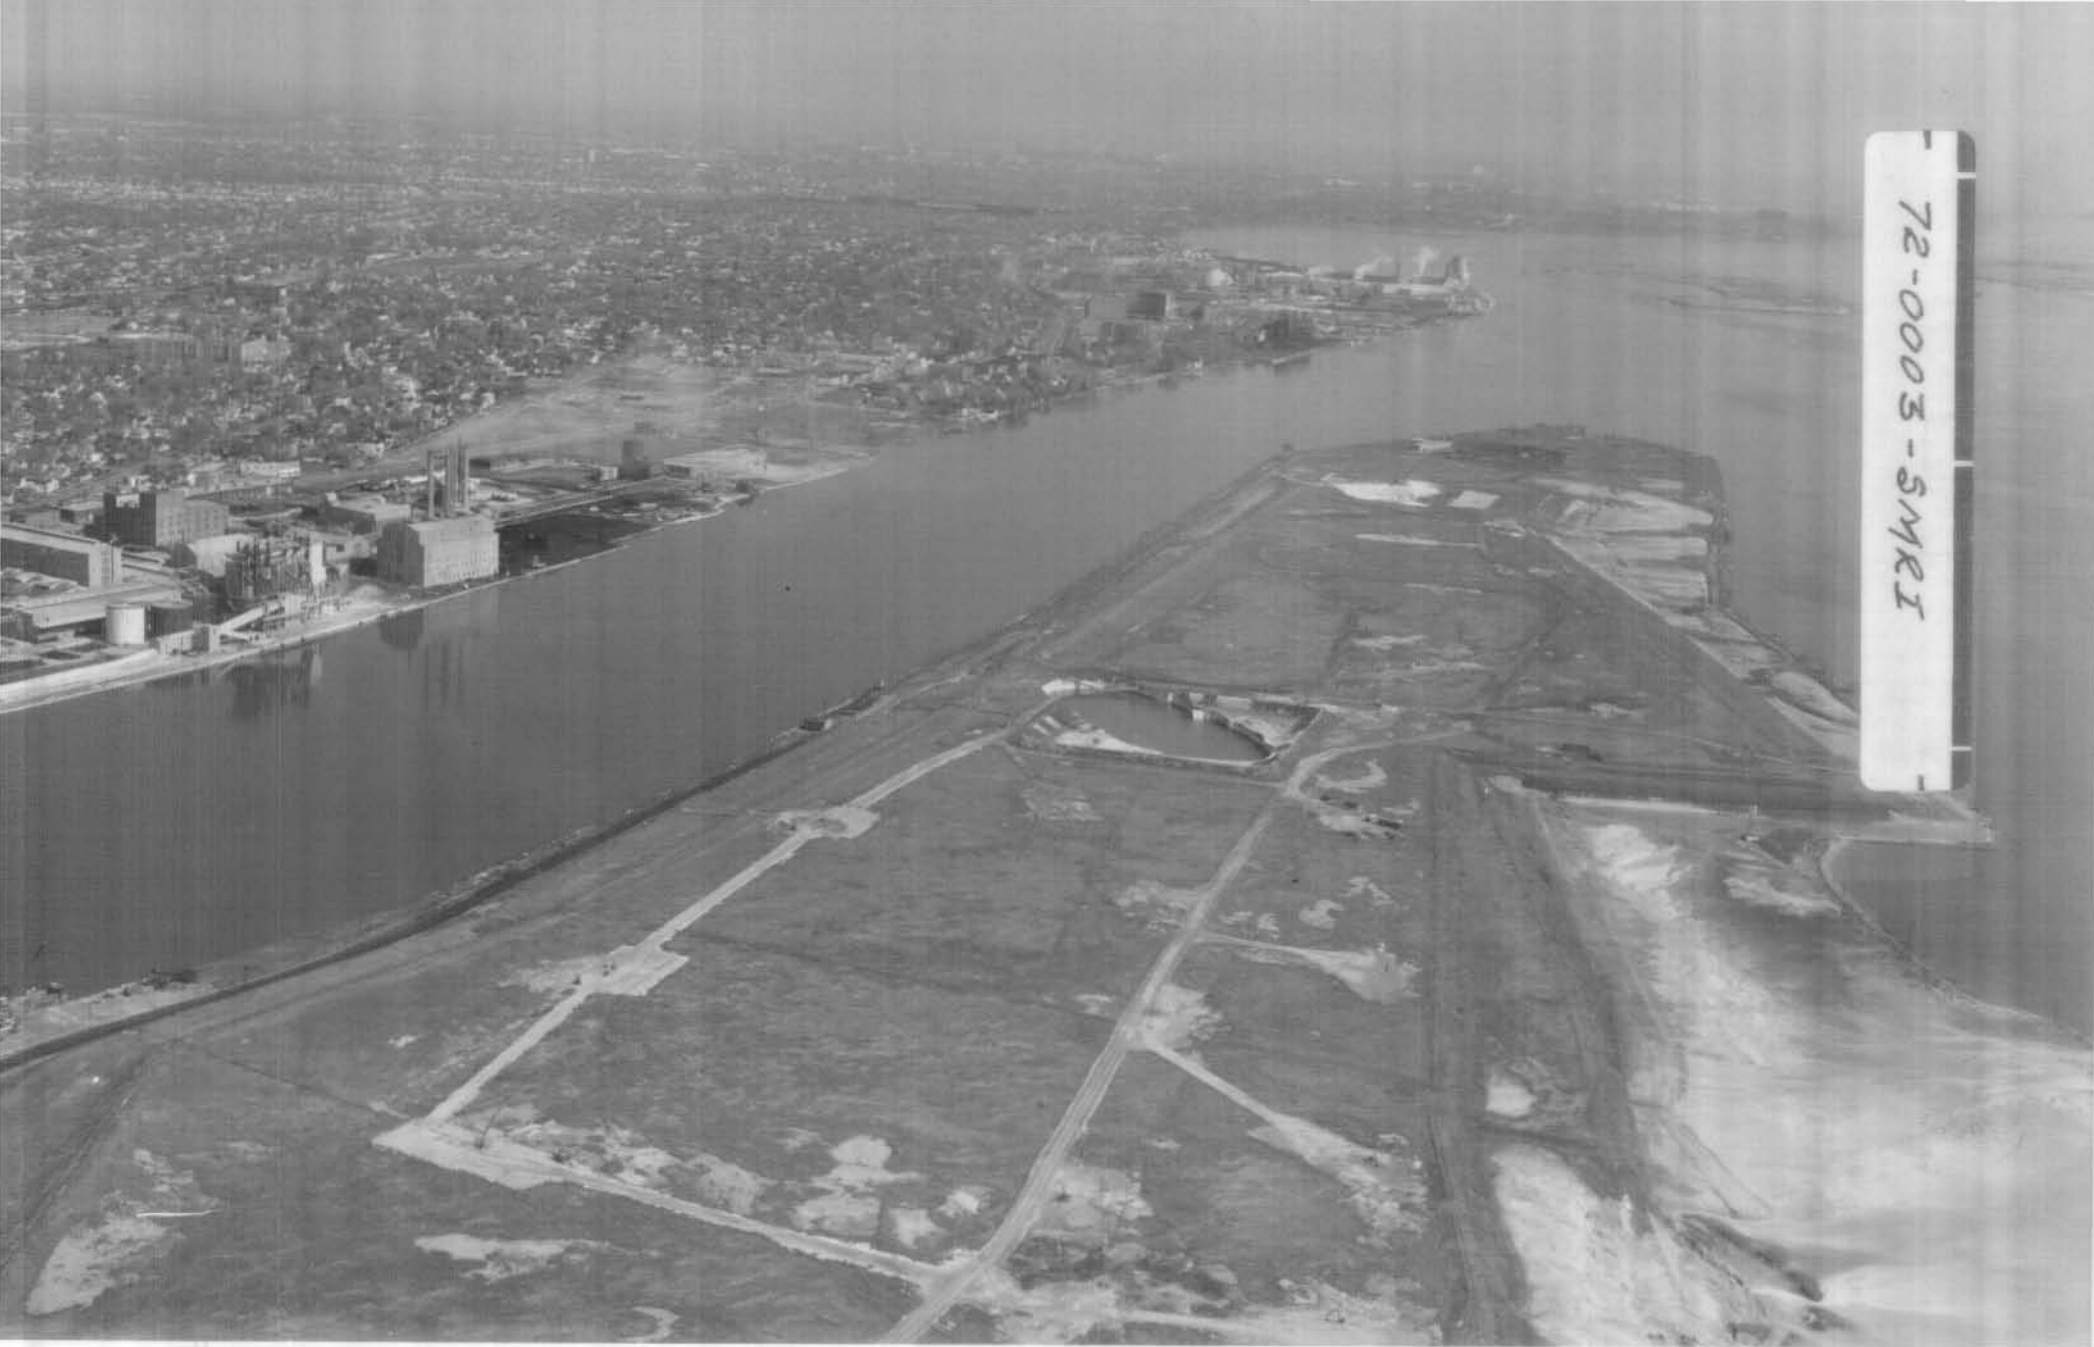
Cover: Air View, Hennepin Point

**Cover:** View of Point Hennepin brine field, Grosse Ile, and downriver section of Detroit River, Detroit, Michigan looking north. Well sites are visible in foreground. Central gallery sinkhole, about three-quarters developed, is the water-filled crater at center. The north gallery sinkhole is partially visible toward upper end of the island. This photo was selected to establish the concept to be developed in the report that while real, the sinkholes represent relatively minor disturbances to the brine field and imperceptible damage to the surrounding community.
